Limited Visual Dam Safety Inspection Summary Report

MA-069

Reservoir 15

May 2006

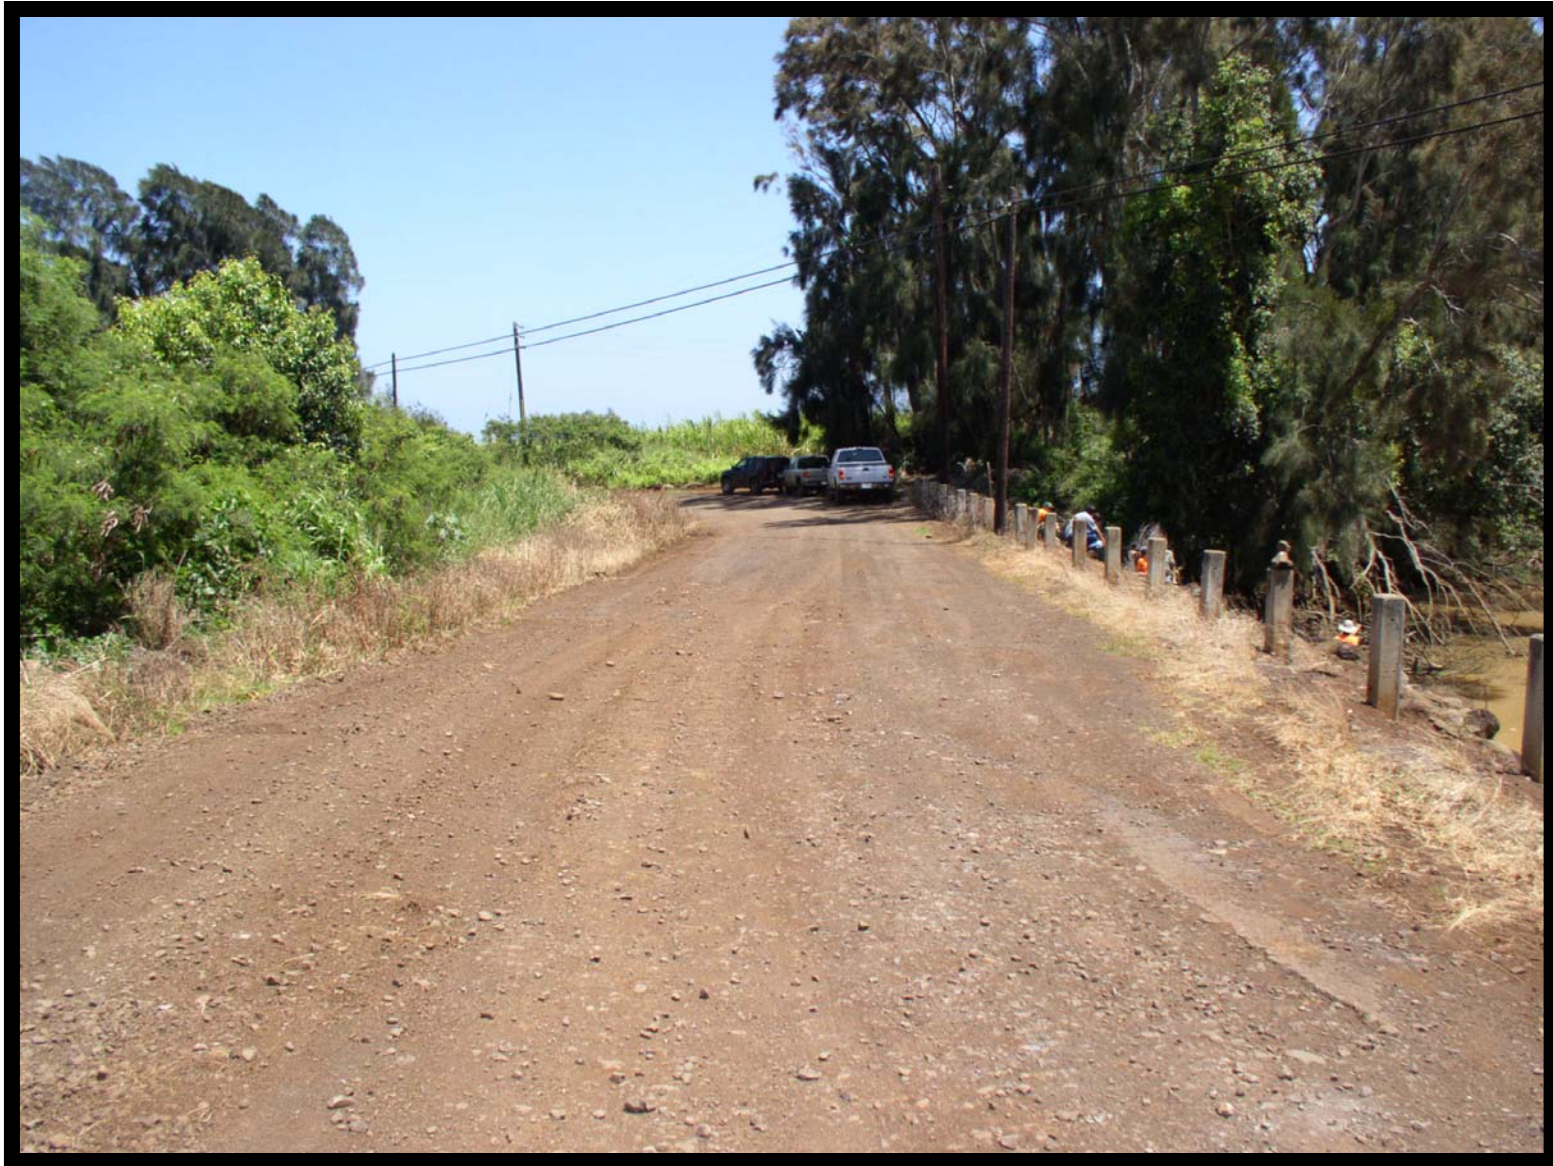
The dam crest was approximately 25 feet wide. It also serves as a county road.

- a. The dam crest appeared to be in satisfactory condition, no corrective actions are required at this time.
- b. Access along the crest was satisfactory.

069 Crest - Note this is also a county highway.

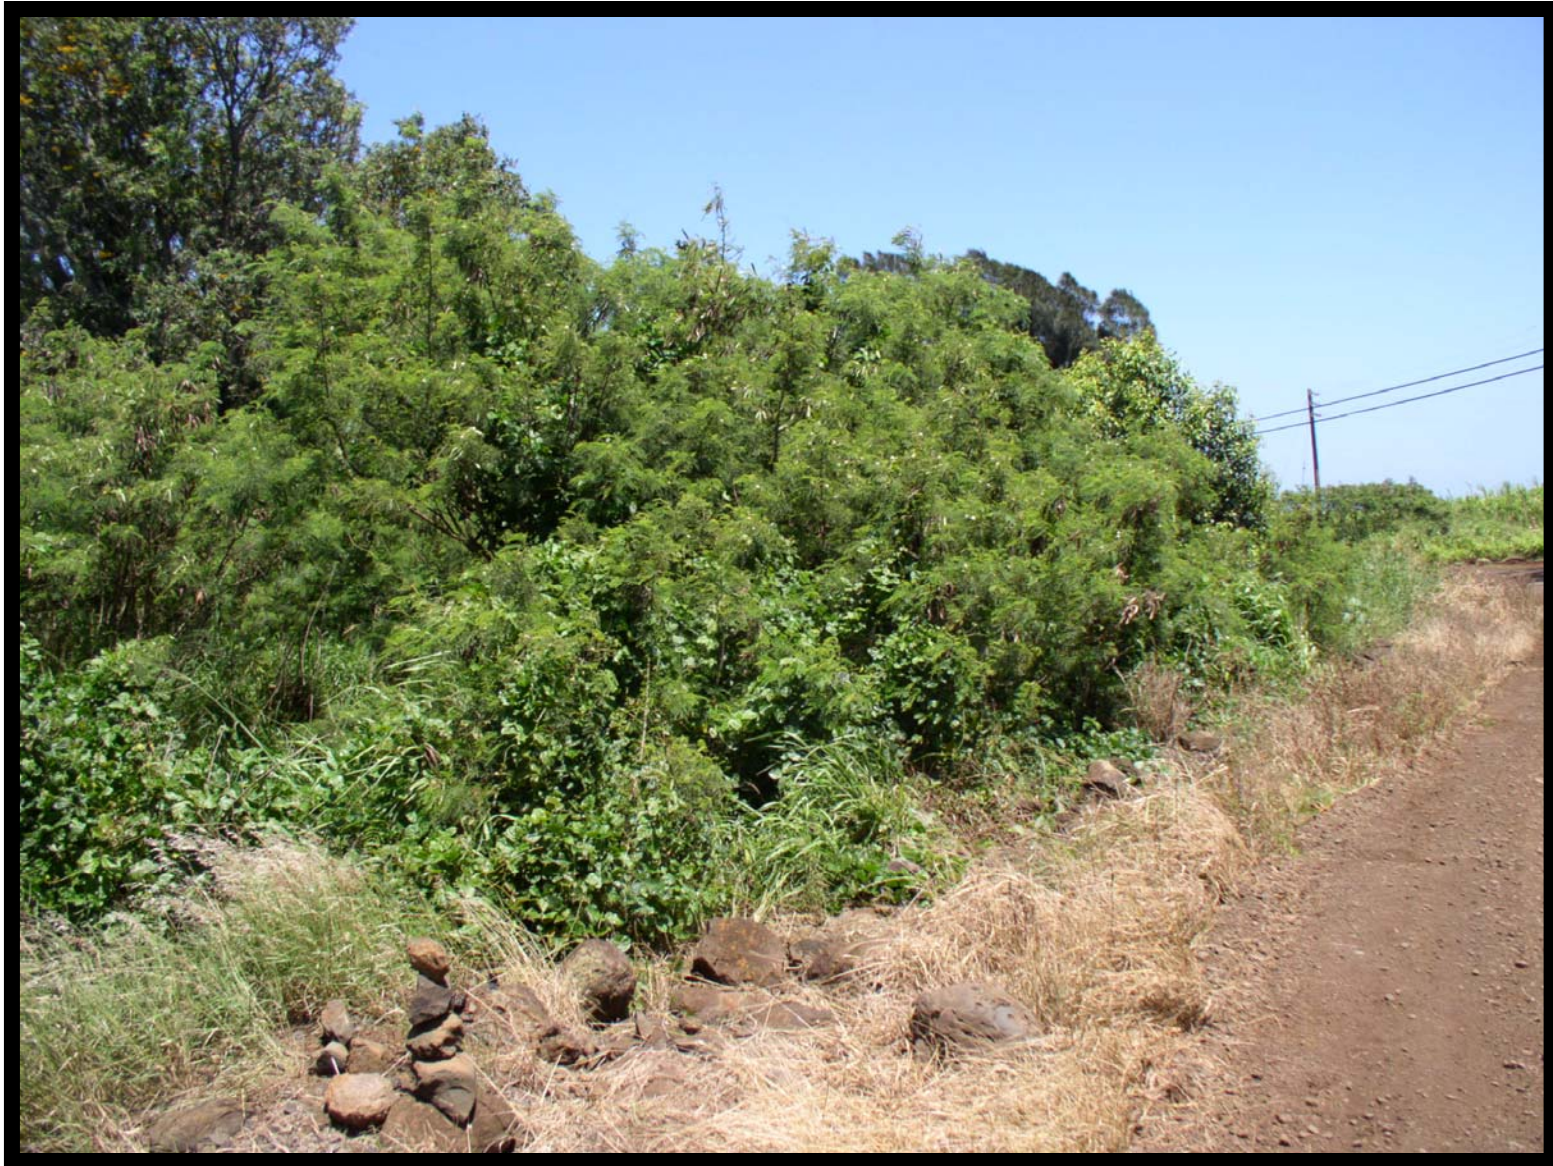
The downstream slope was approximately 2 on 1. Trees and tall grass were growing on the downstream slope, obscuring it from visual inspection.

- a. The downstream slope appeared to be in fair to poor condition and requires corrective action.
- b. Slope protection needs maintenance. Need to remove trees and other vegetation from the downstream slope.
- c. The downstream slope was not visible due to high grass and bush vegetation. Clear high vegetation and maintain low to enable easy inspection.
- d. Trees were observed on the downstream slope. Trees have been identified as the probable cause of piping failures and can possibly cause severe damage to the embankment if they are uprooted during high winds. Corrective action is required to remove tree hazards from the dam. Acceptable remedies include removal of the tree and its root structure down to a 2-inch diameter and reconstructing the damaged embankment section. All repair work shall be accomplished as per the requirements of a licensed geotechnical or structural

069 Down slope - Note the downstream slope is completely obscured and overgrown by trees and tall vegetation.

engineer. Routinely monitor the damaged area for signs of settlement and seepage.

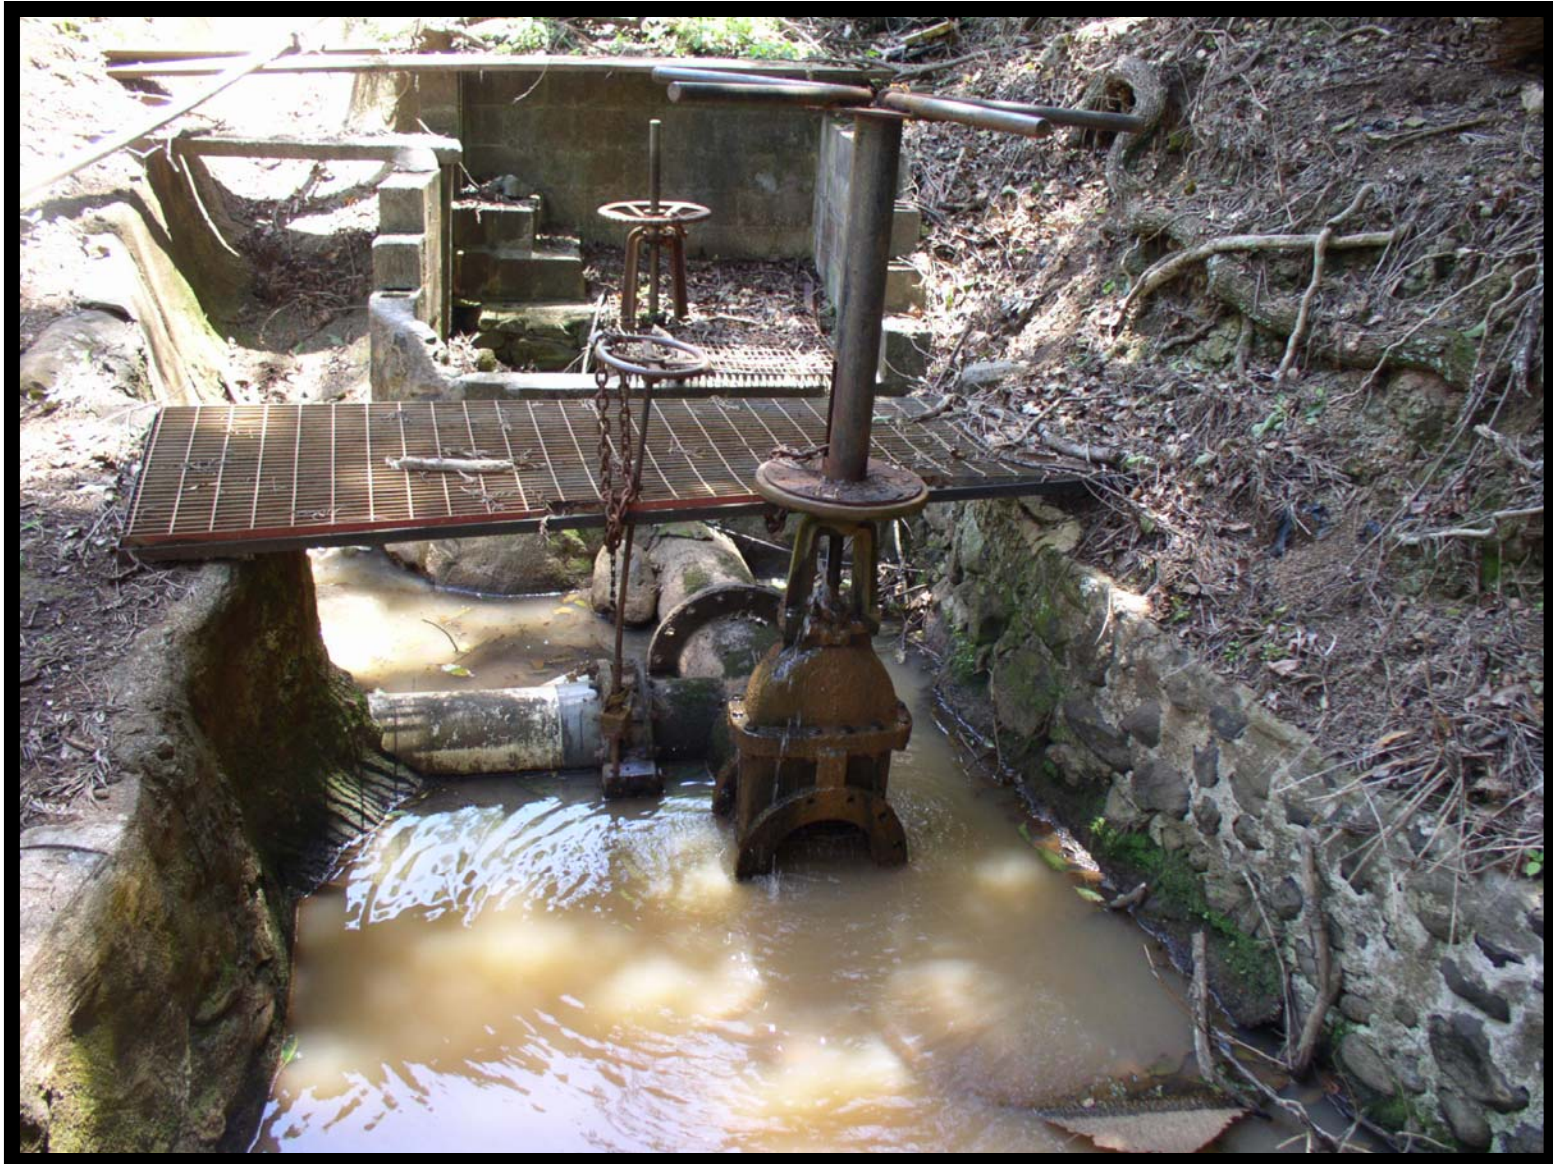
The outlet works consist of a 12-inch diameter DIP pipe controlled on the downstream side of the dam by a valve.

- a. The outlet works were not tested.
- b. The outlet works appear to be in satisfactory condition. No corrective actions are required at this time.

069 Out valve - View of the outlet pipe and control valve

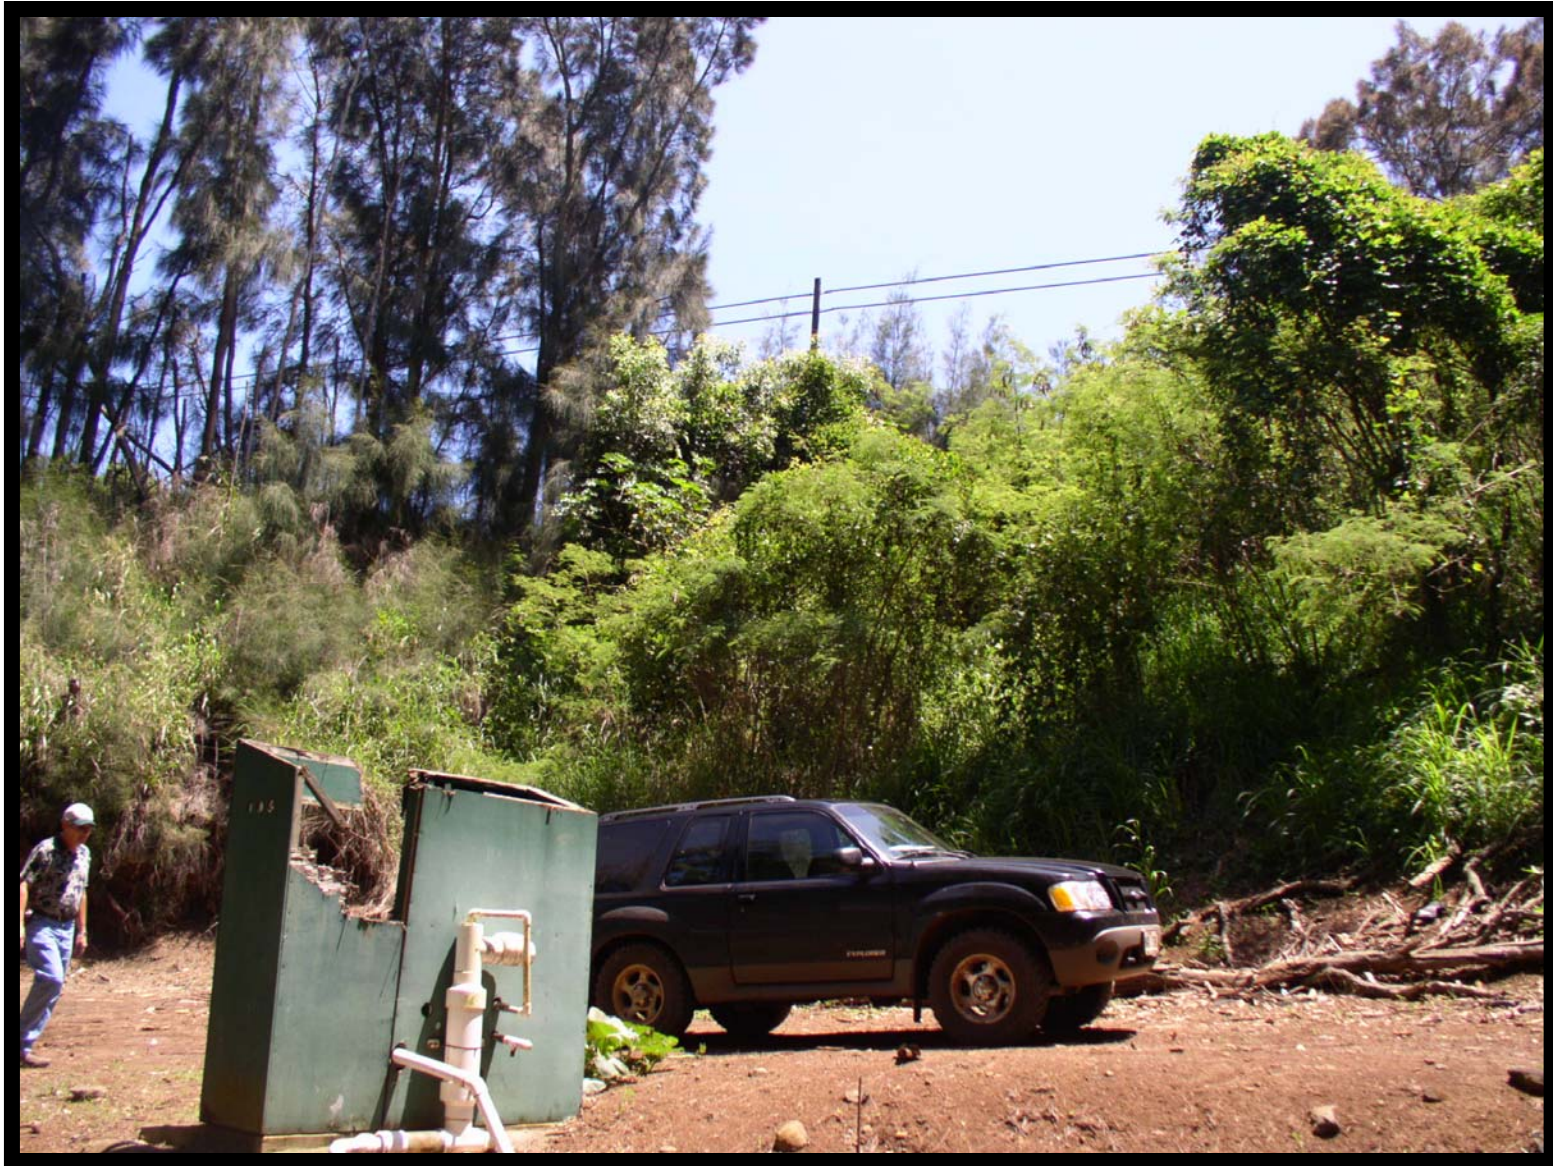
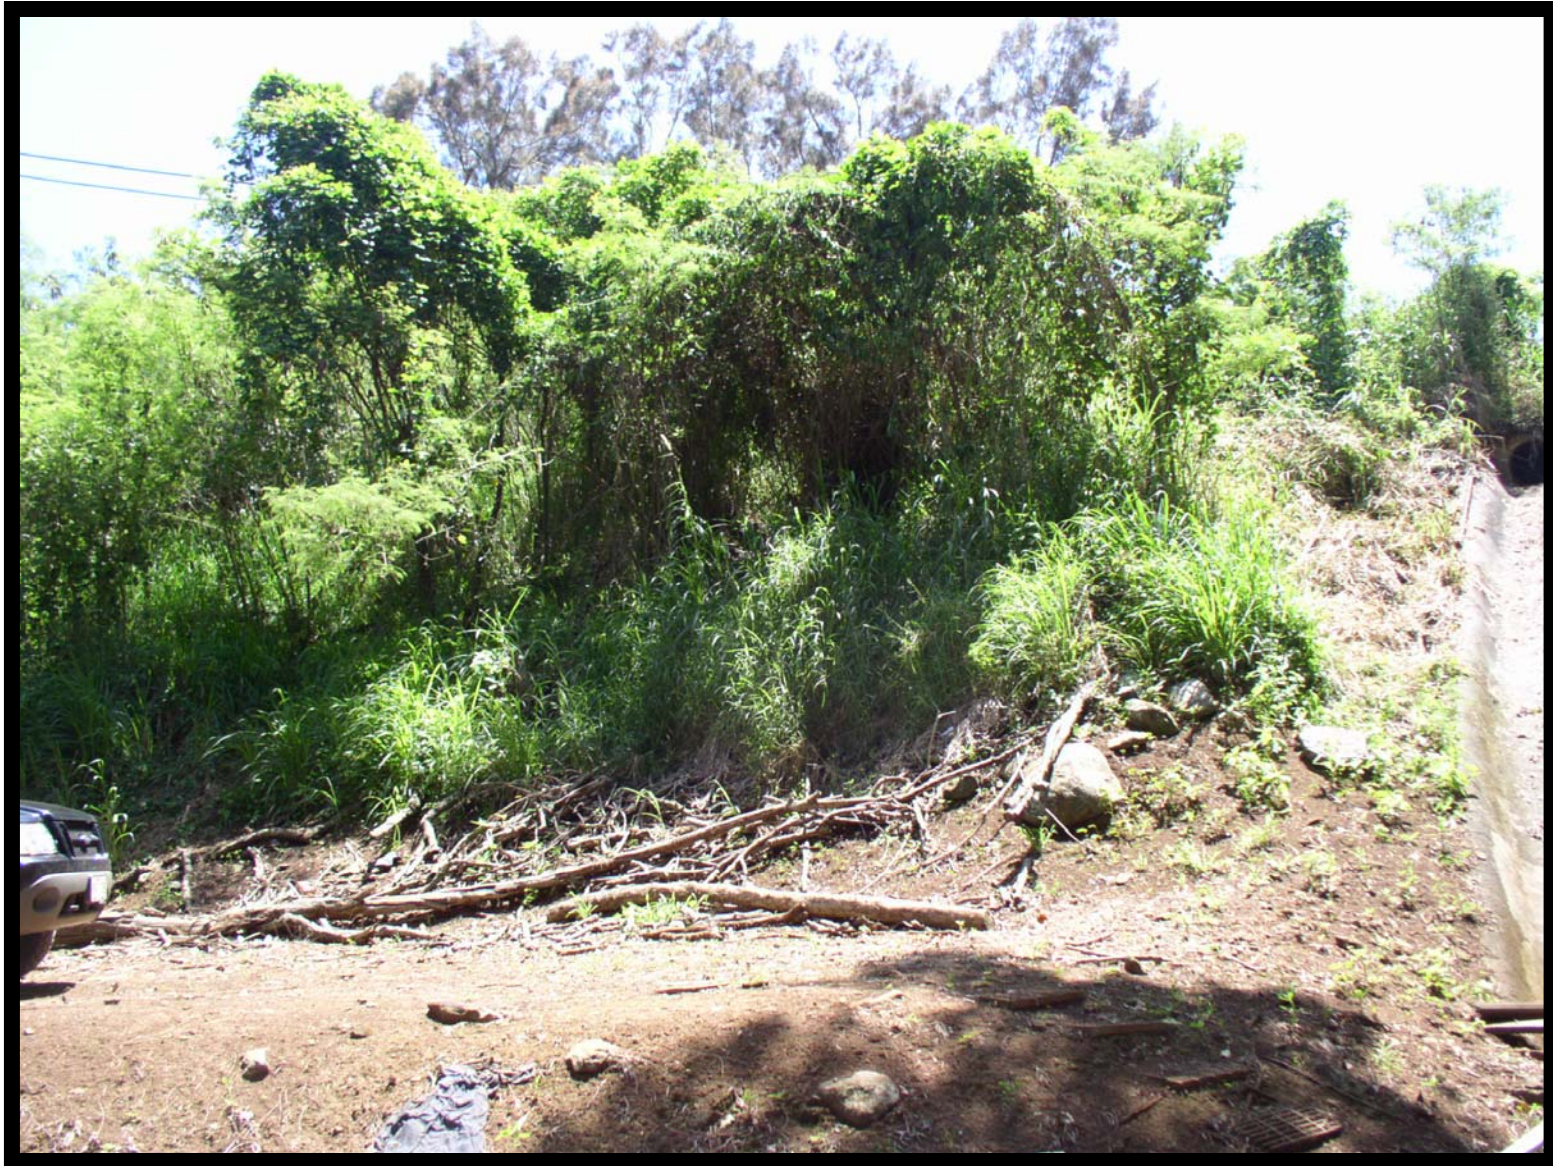
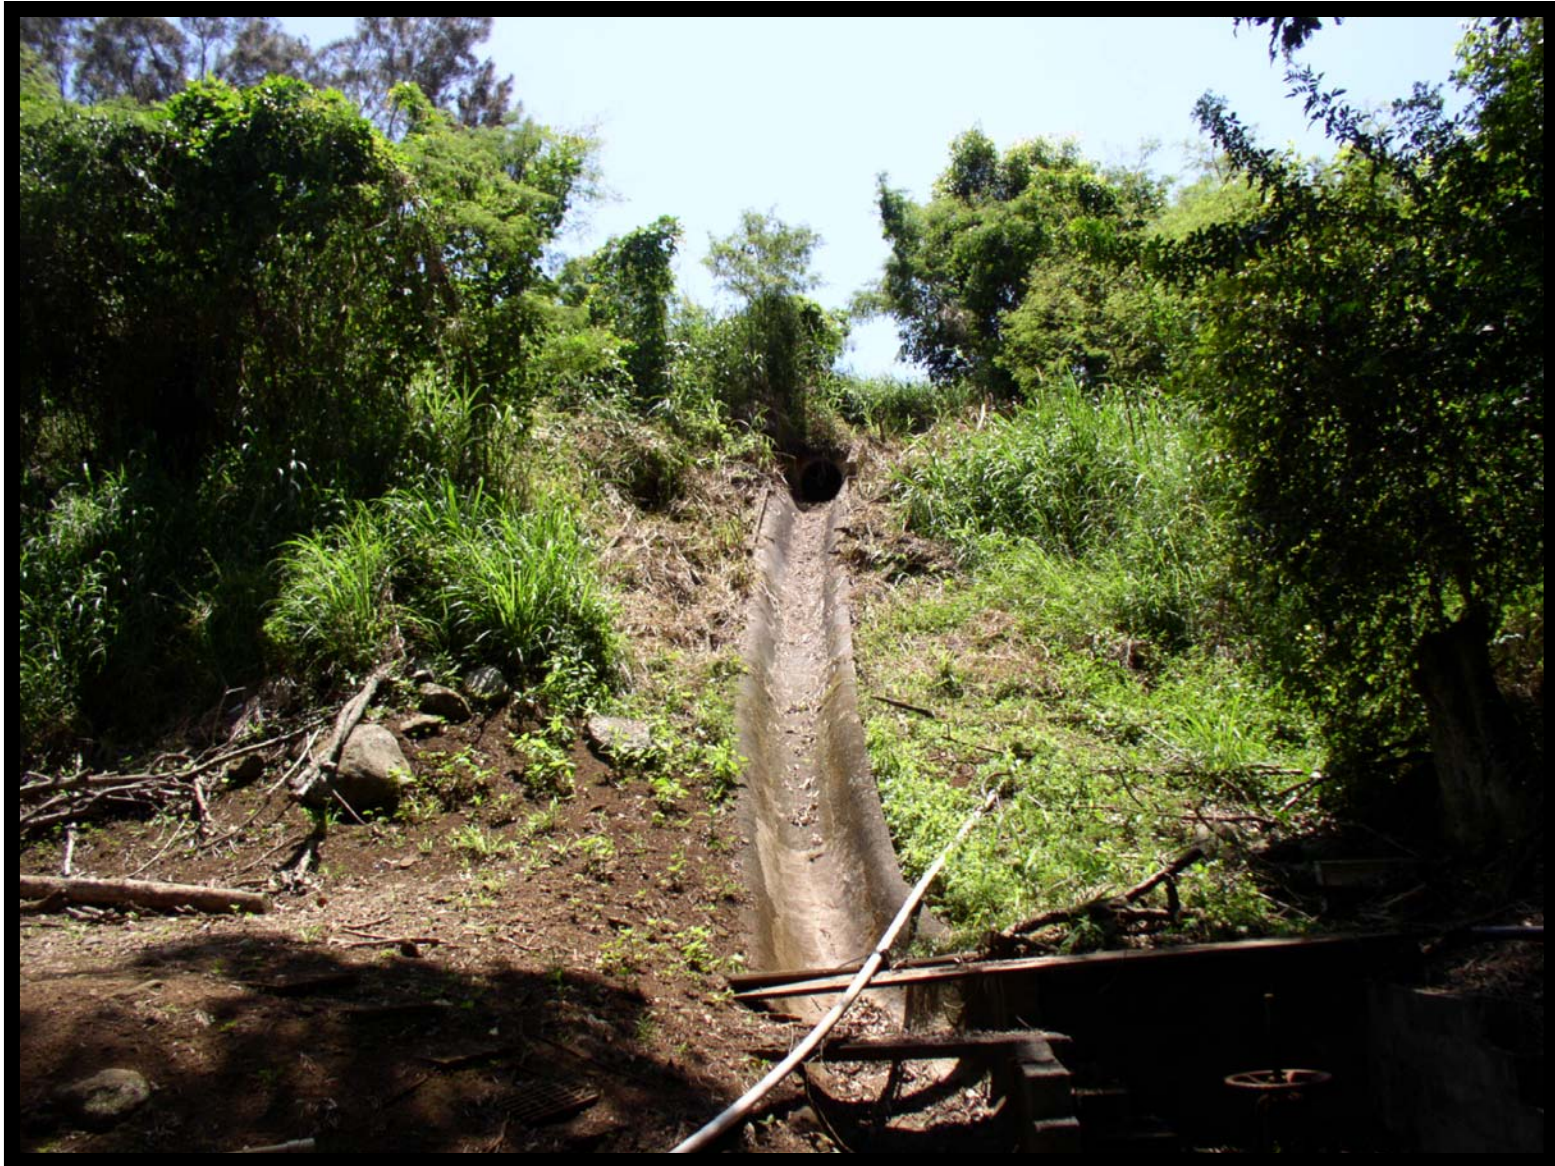
069 Panoramic view of the downstream slope

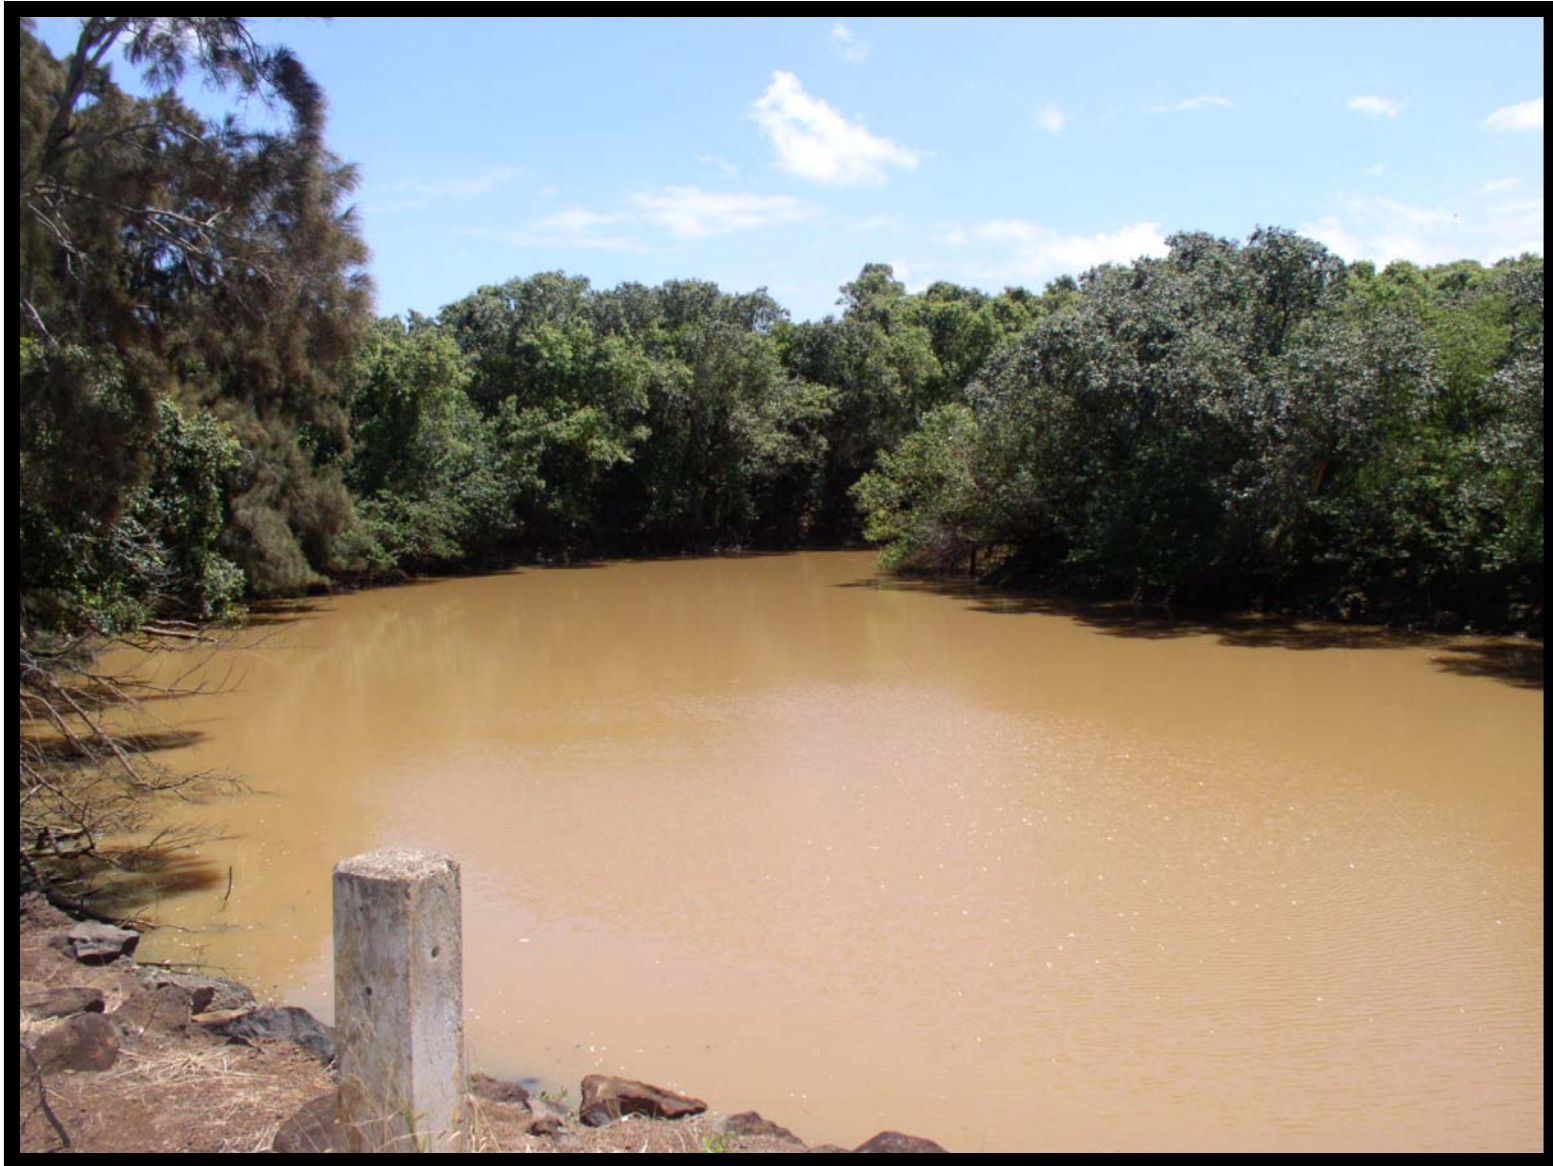
069 Reservoir

The reservoir was 25 feet per gage at the time of inspection. The normal operating level is 7 to 29 feet per gage. A staff gage was observed in the middle of the reservoir.

- a. The reservoir appeared to be in satisfactory condition, no corrective actions are required at this time.

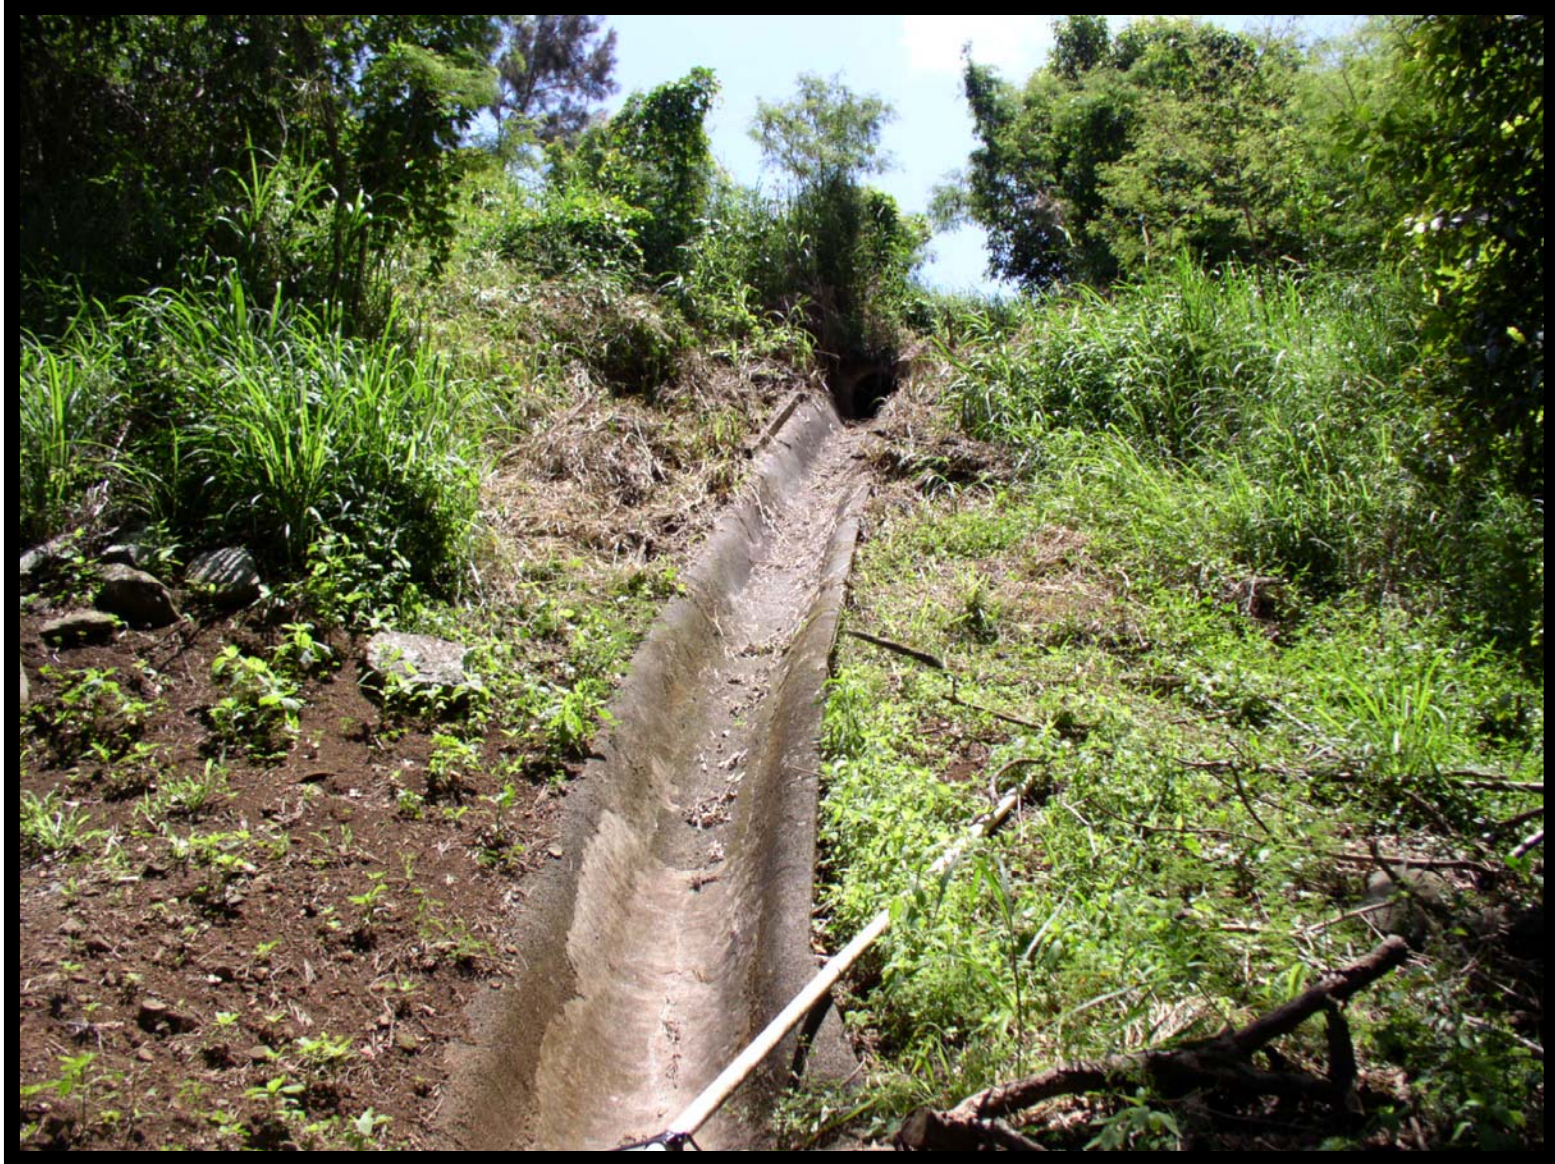
069 Spillway

This spillway consisted of a concrete lined U-shape channel approximately 2 feet wide by 1 foot high. The spillway approach was clear. There was no erosion observed near the spillway.

- a. The Spillway appeared to be in satisfactory condition, no corrective actions are required at this time.

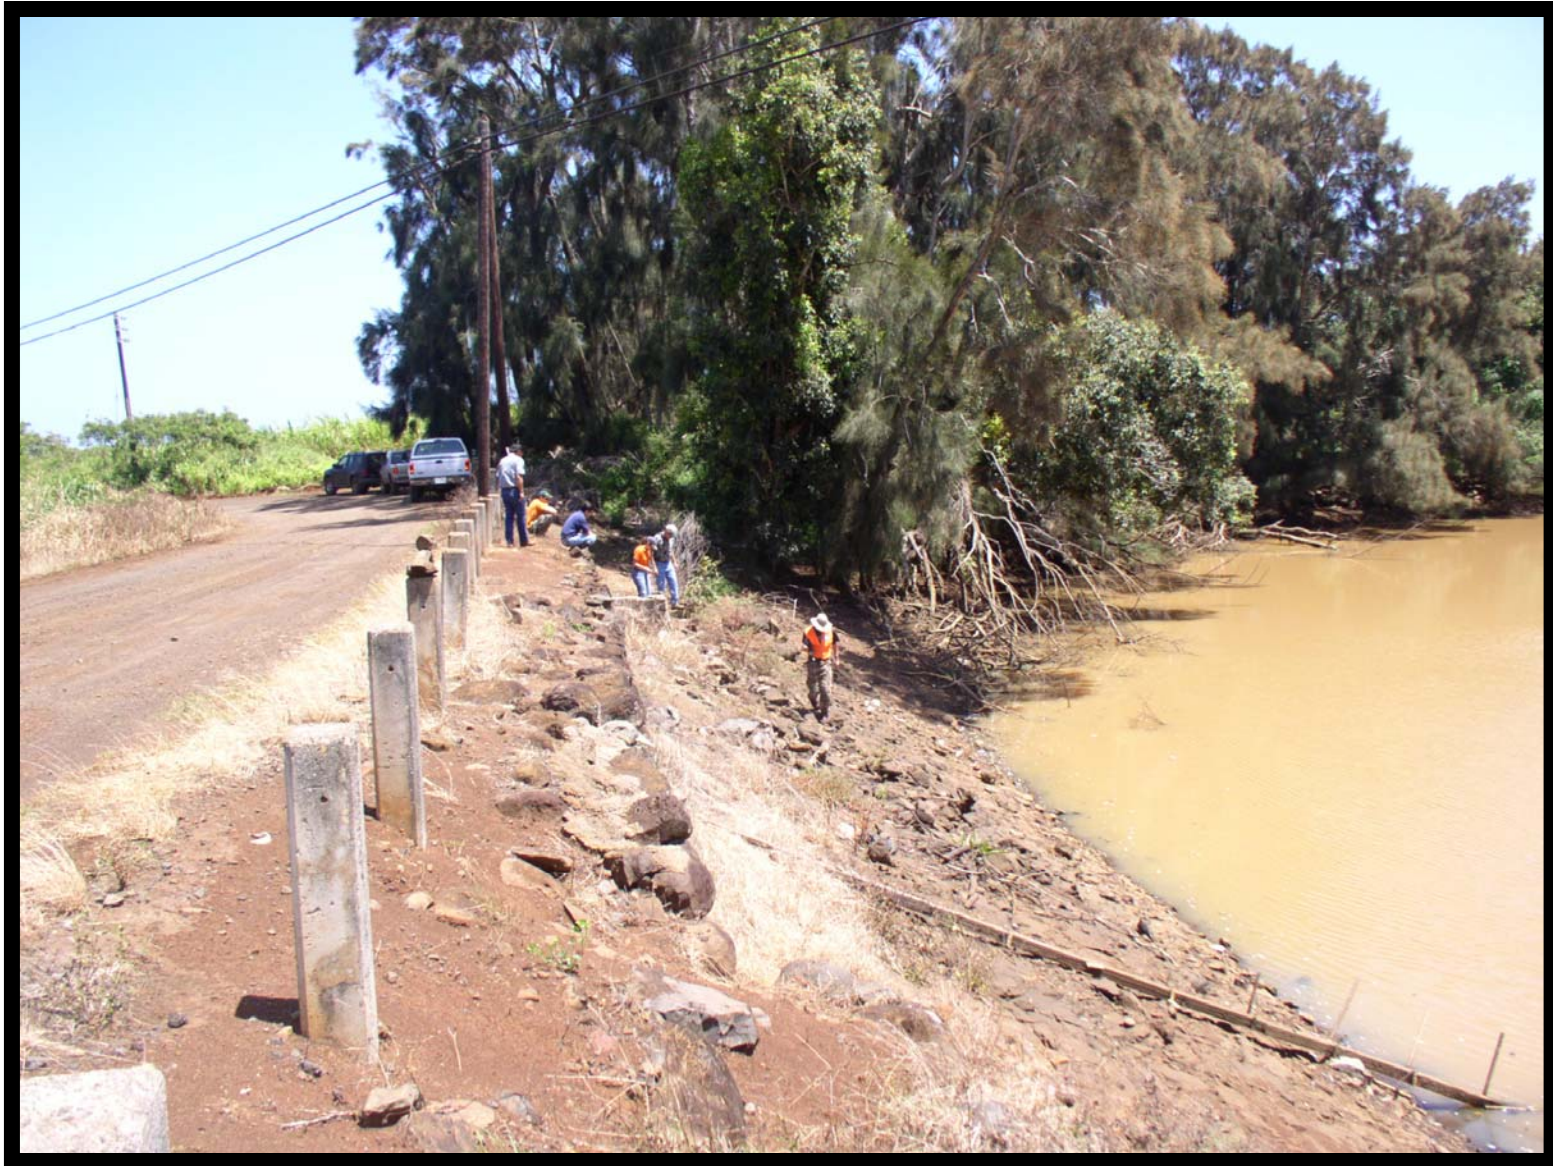
069 Upslope

The upstream slope is grouted rip rap on a 3 on 1 slope. There are large trees and other tall vegetation growing beyond the center part of the upstream slope.

- a. The upstream slope appeared to be in fair to poor condition and requires corrective action.
- b. Slope protection needs maintenance. Description: Need to remove trees and other vegetation from the upstream slope.

- c. The upstream slope was not visible due to high grass and bush vegetation. Clear high vegetation and maintain low to enable easy visual inspection.

- d. Trees were observed on the dam embankment. Trees have been identified as the probable cause of piping failures and can possibly cause severe damage to the embankment if they are uprooted during high winds. Corrective action is required to remove tree hazards from the dam. Acceptable remedies include removal of the tree and its root structure down to a 2-inch diameter and reconstructing the damaged embankment section. All repair work shall be accomplished as per the requirements of licensed geotechnical or structural engineers. Routinely monitor the damaged area for signs of settlement and seepage.
